CALIFORNIA DIVISION OF MINES AND GEOLOGY

Fault Evaluation Report FER-57

December 1, 1977

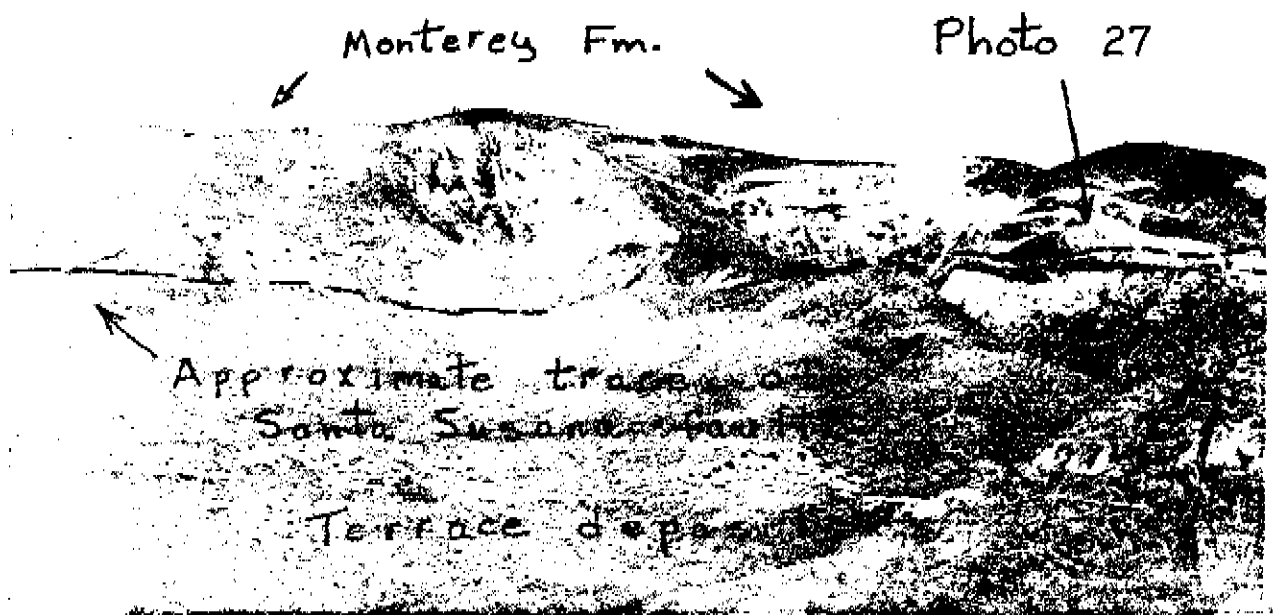
Photo 26. View north in northern Tapo Canyon area. Principal strand of north-dipping Santa Susana fault zone extends approximately along principal break in terrain between subdued, terraced topography of foreground, as opposed to hilly, Oak Ridge in background. Silicified shale of Monterey/Modelo Formation making up portion of Oak Ridge shown is thrust south relatively over older alluvium/terrace deposits of late Quaternary age of foreground.

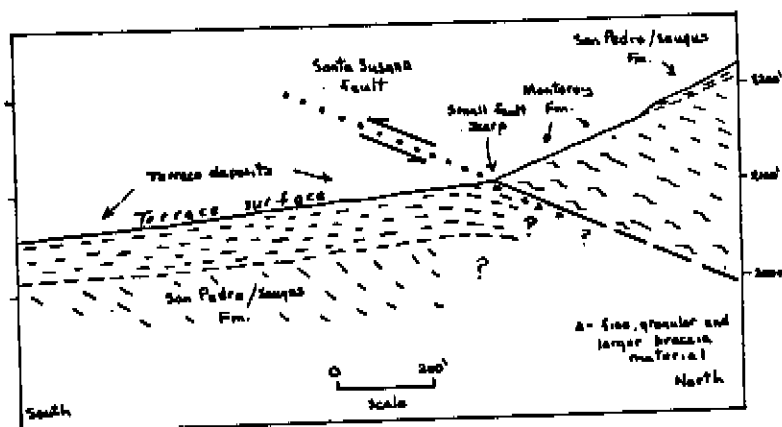
Figure 13. Generalized cross section, north Tapo Canyon area, north of Simi Valley, shows late Quaternary terrace deposits and overlying erosional surface being overridden by siliceous shale of Monterey Formation of middle - late Miocene age. Note how faulting has caused the terrace deposits to bend under the fault.
